HISTORIC STRUCTURES REPORT

CROOK HOUSE

SEPTEMBER 1984

SAN JUAN ISLAND
NATIONAL
HISTORICAL PARK

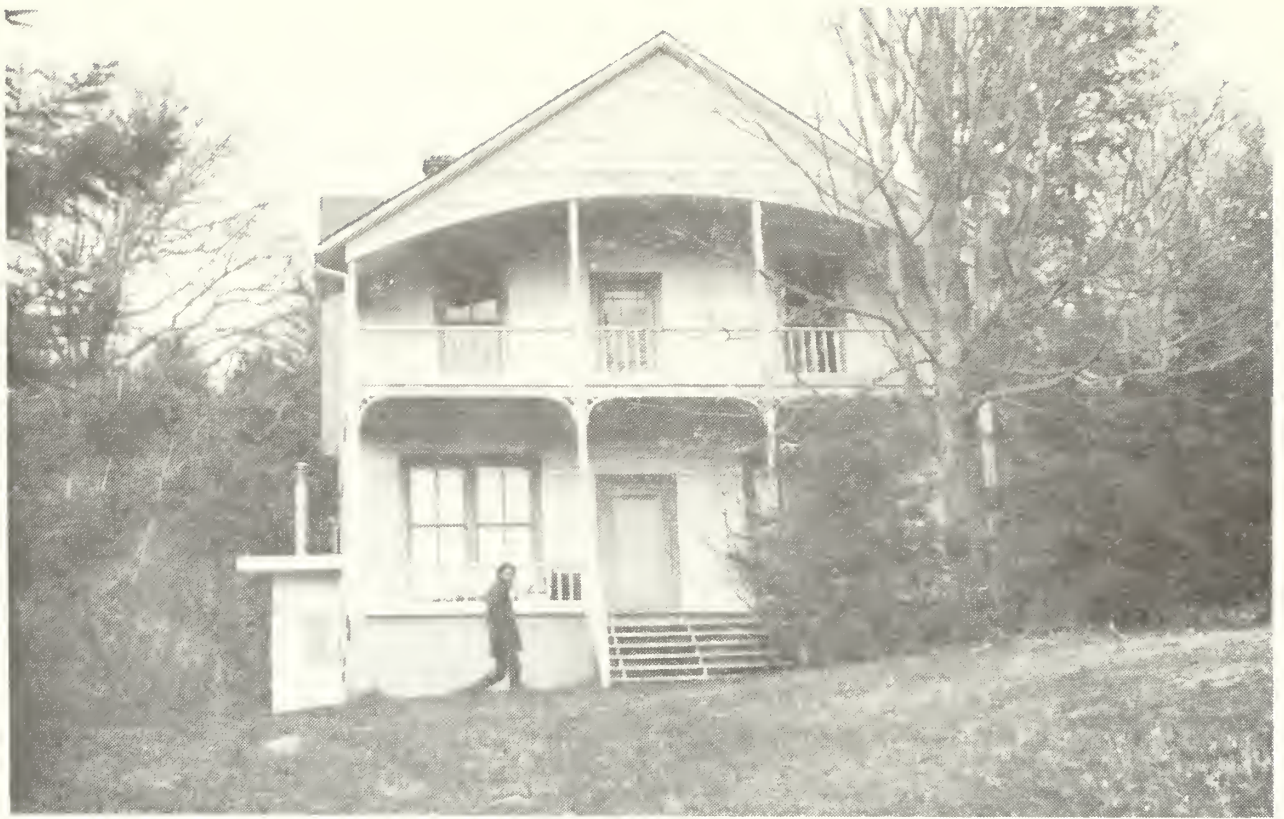
FIGURE 26 West elevation of Crook House, 1975. Photo by Harold LaFleur, Jr., National Park Service.

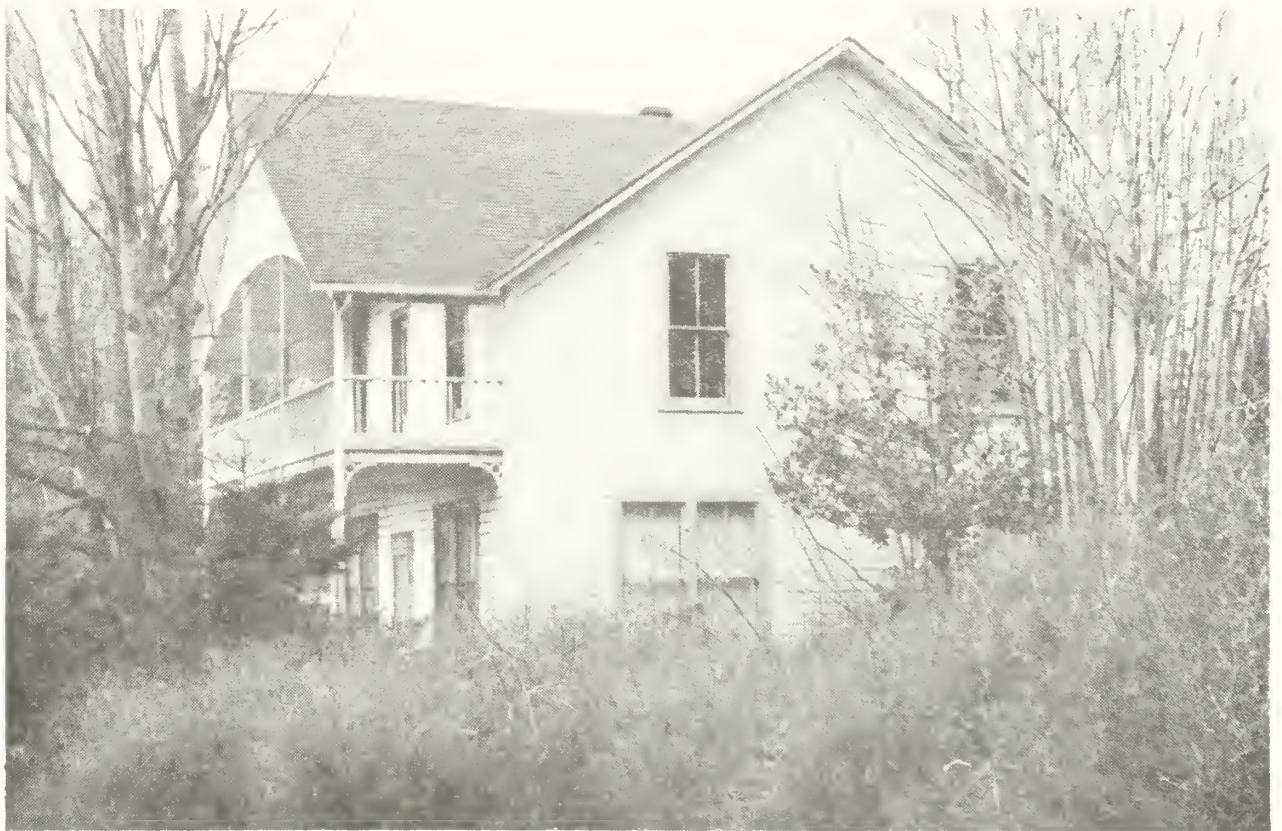
FIGURE 27 South elevation of Crook House, 1975. Photo by Harold LaFleur, Jr., National Park Service.

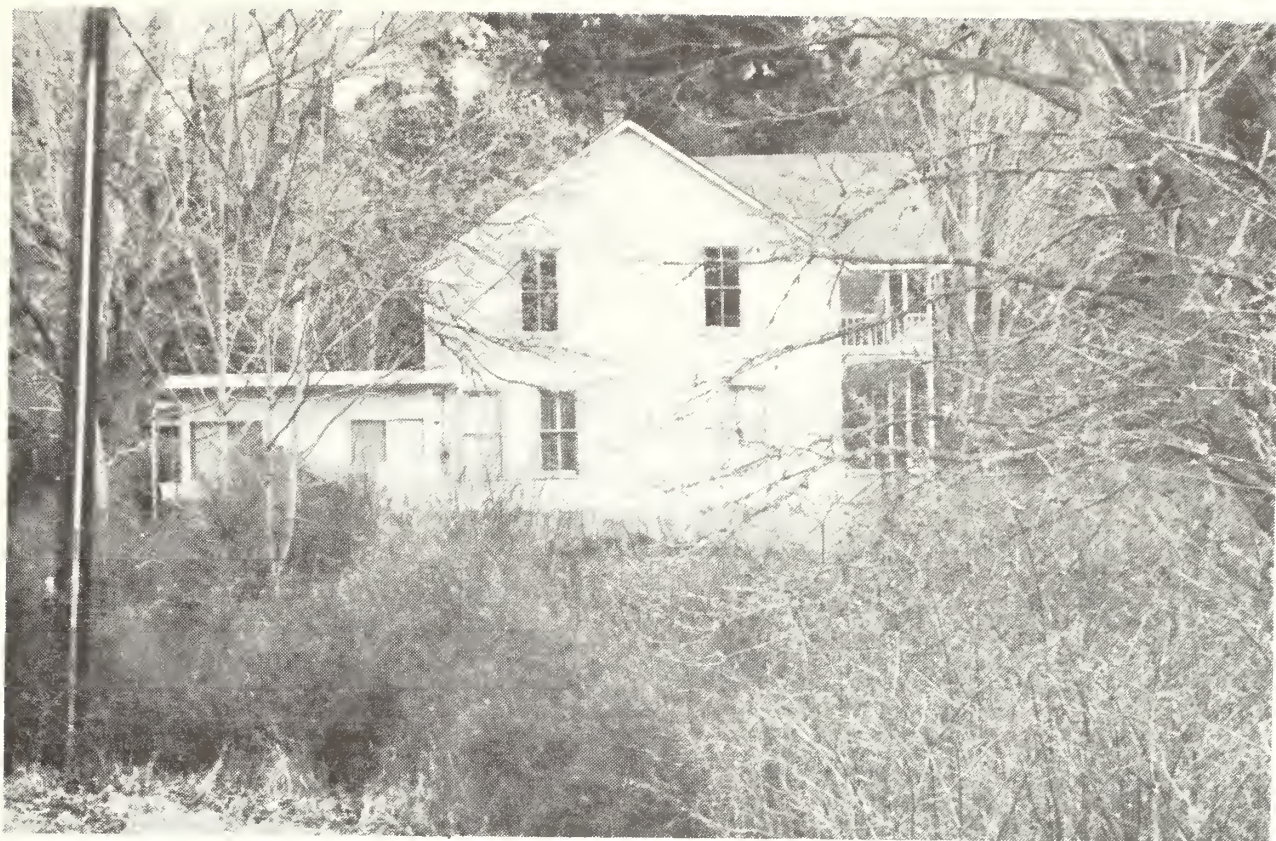
FIGURE 28 North elevation of Crook House, 1975. Photo by Harold LaFleur, Jr., National Park Service.

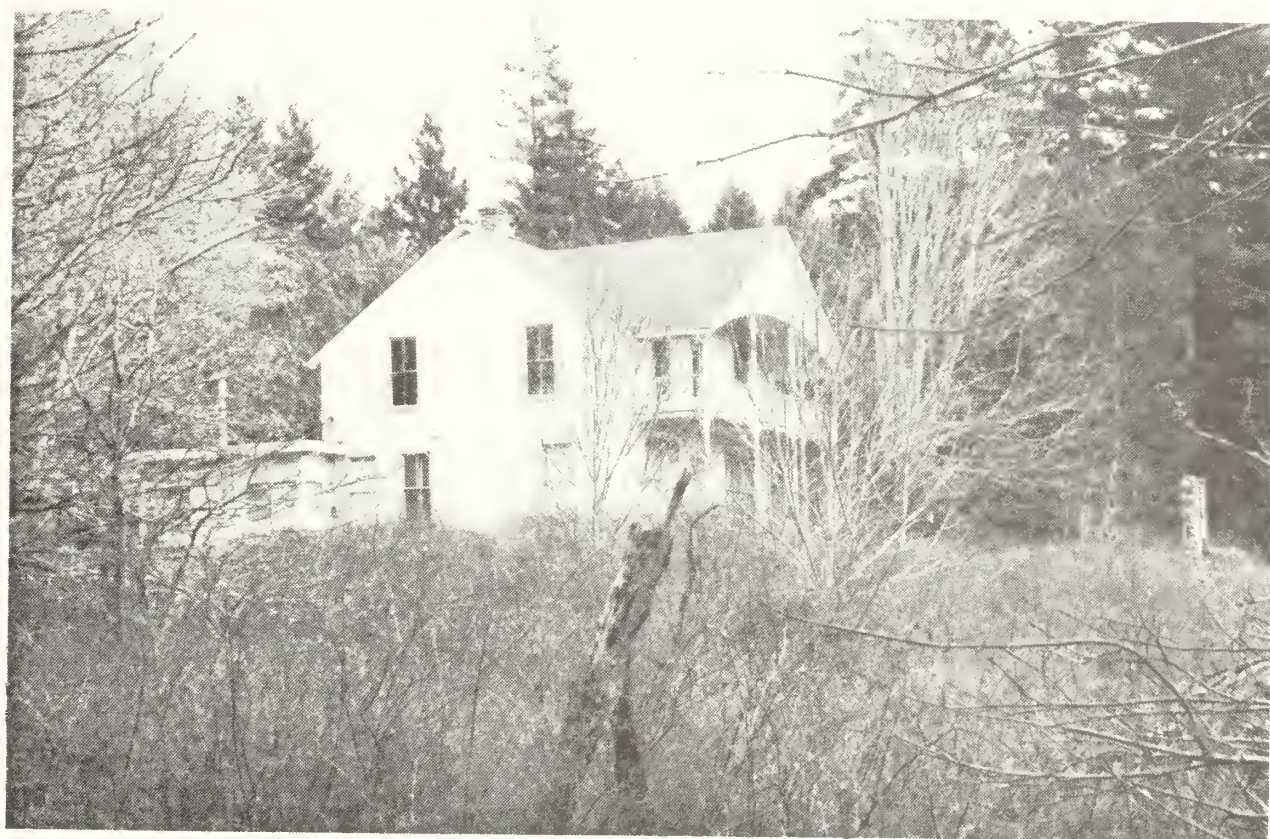
FIGURE 29 North elevation of Crook House, 1975. Photo by Harold LaFleur, Jr., National Park Service.

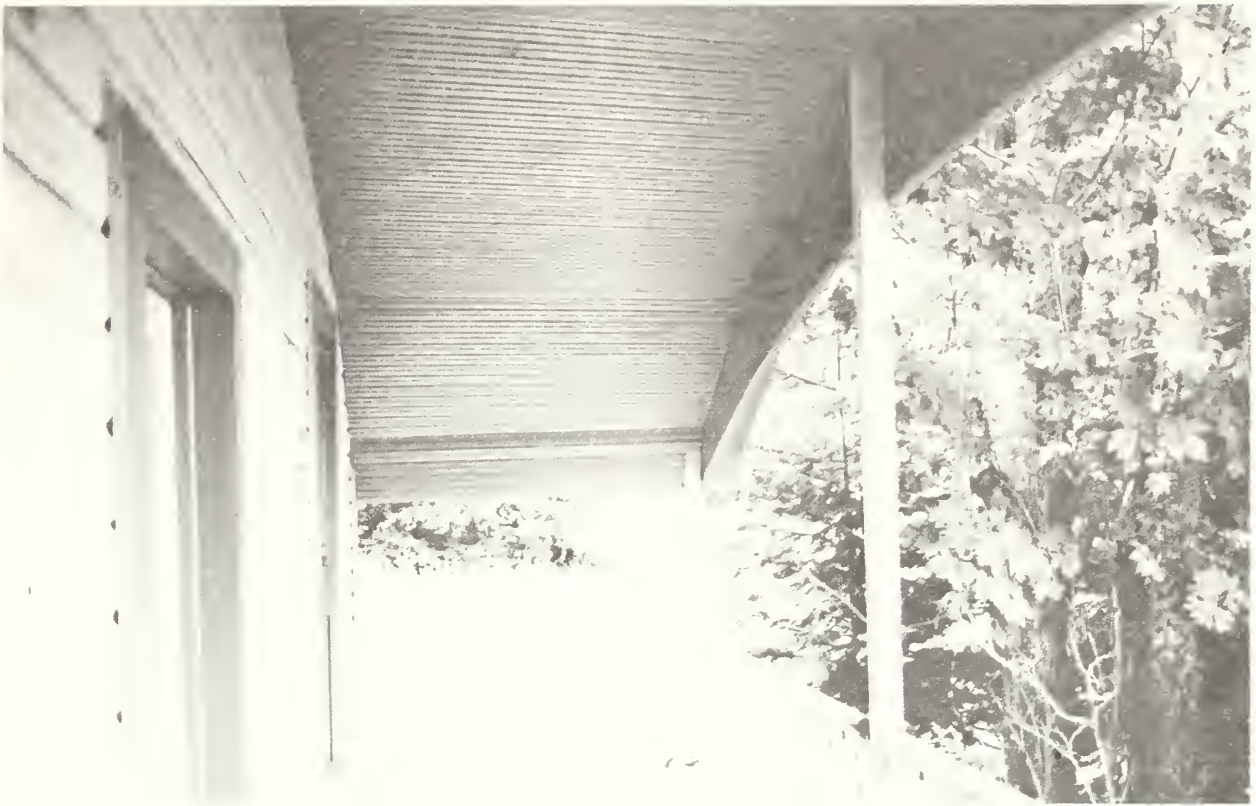
The second floor porch structure consists of 2"-by-6" girders between the 4"-by-4" columns and between the columns and the house. Running north-south between the girders are 2"-by-6" joists. All structural connections are butt jointed and toenailed. A 1"-by-4" ledger is attached to the house wall to help support the deck. The deck is a 1"-by-5 1/4" tongue-and-groove beaded board with the pattern facing down and visible as the first floor porch ceiling. It extends 2" on all sides beyond the structural supports. The ceiling of the second floor porch is a similar beaded board, which varies in height, and roughly follows the gable end arch (Figure 36).

FIGURE 36 Beaded board ceiling of second floor porch, 1984. Photo by Barry Schnoll, National Park Service.

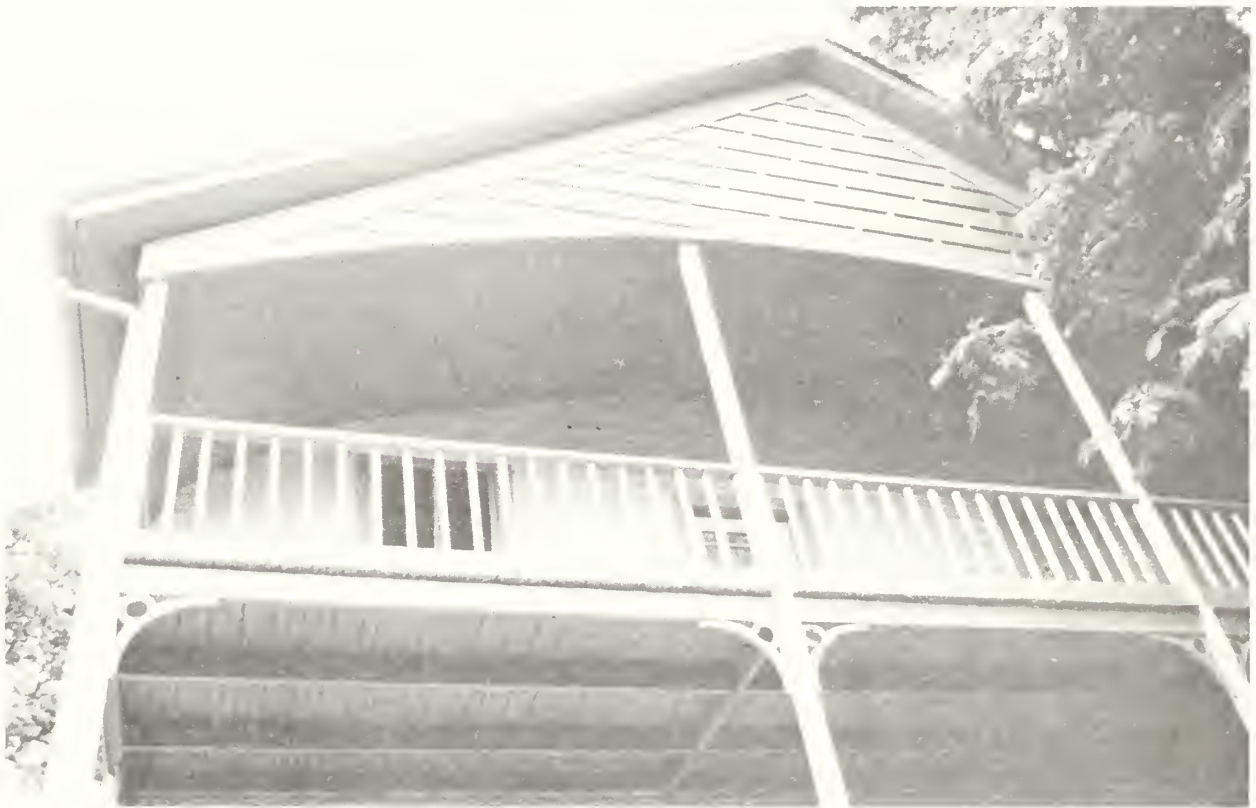
The gable end pattern is board and batten construction, although it is mainly decorative. A layer of 1"-by-9" boards are attached between the columns and roof structure, with batten strips applied horizontally and vertically. The curved lower trim strips are cut from flat 1"-by-4" material and pieced together (Figure 37).

FIGURE 37 Crook House porch with distinctive gable end treatment, 1984. Photo by Barry Schnoll, National Park Service.

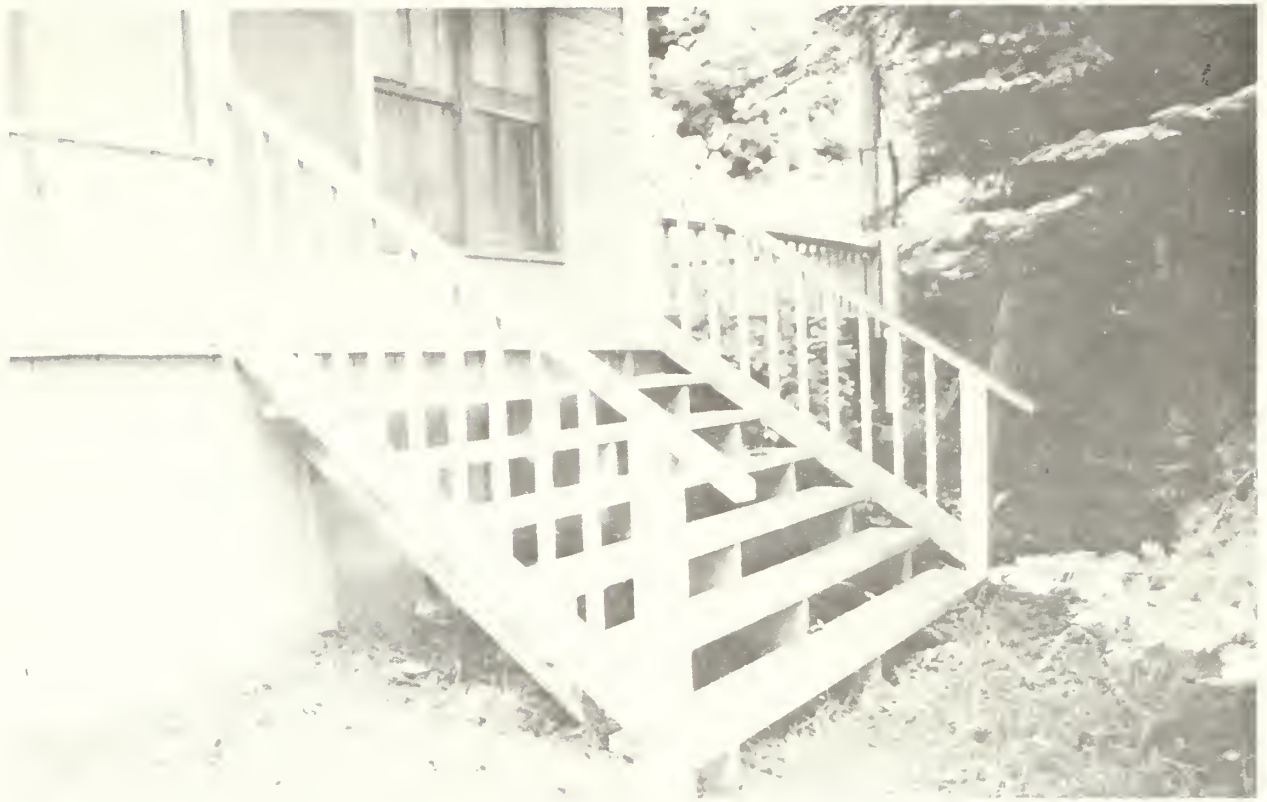
STAIRS to grade from the porch have a similar railing construction. Each step consists of three 2"-by-4"s laid flat resting on three evenly spaced 2"-by-12" stringers. Where the stringers meet the porch structure, a 2"-by-4" upright adds support (Figure 38).

FIGURE 38 West porch steps of Crook House, 1984. Photo by Barry Schnoll, National Park Service.

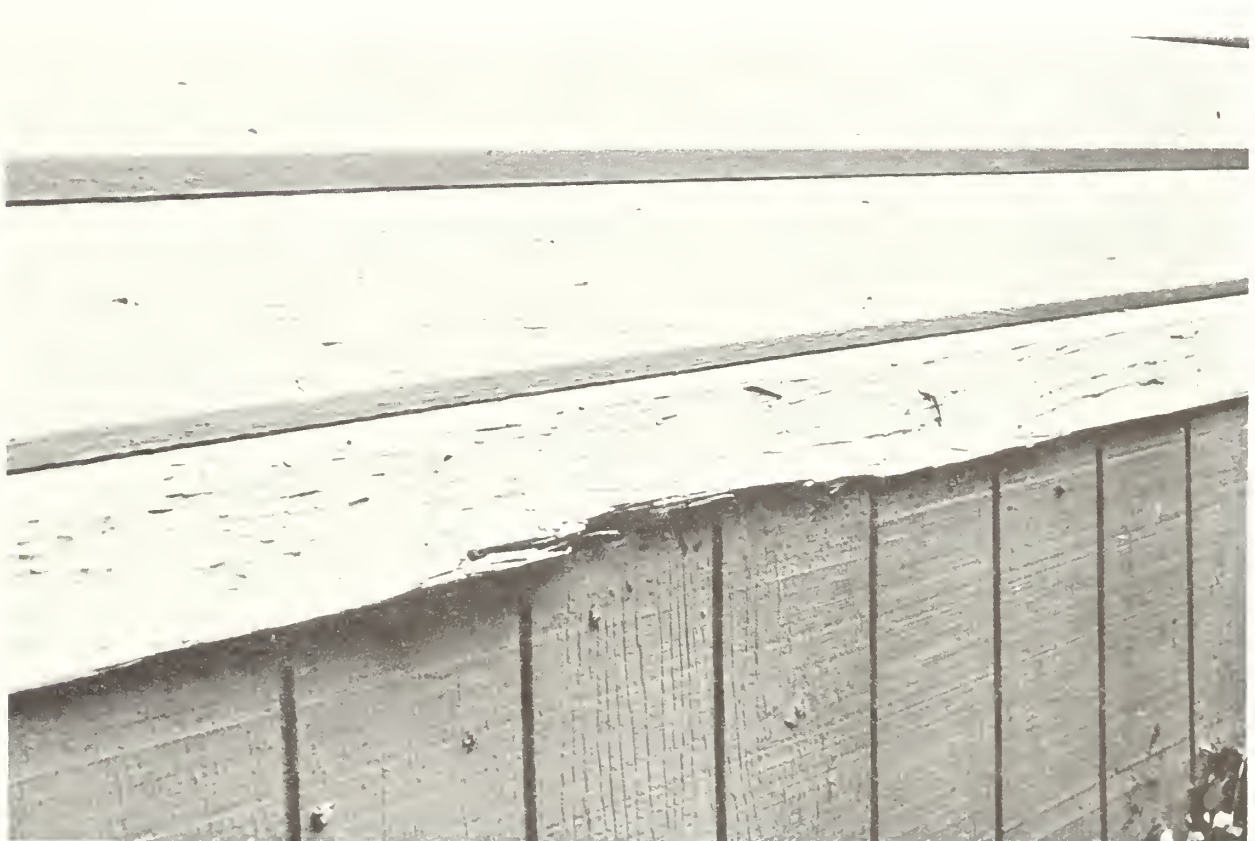
The exterior skin of the building is painted 1"-by-5" bevel edge shiplap cedar siding applied directly to the wall studs (Figure 44). An asphalt shingle roof with metal flashing is laid over a 1/2" plywood roof deck. Wood gutters with metal ends are found on the existing roof structure, yet do not appear in the historic photos. The entire roof system and gutters are in poor condition and in need of major repair and replacement (Figure 45).

FIGURE 44 Bevel edge shiplap siding and T1-11 skirting, south wall of Crook House, 1984. Photo by Barry Schnoll, National Park Service.
